# 1979 Mutineer

## Centerboard Trunk Removal

June 30, 2011

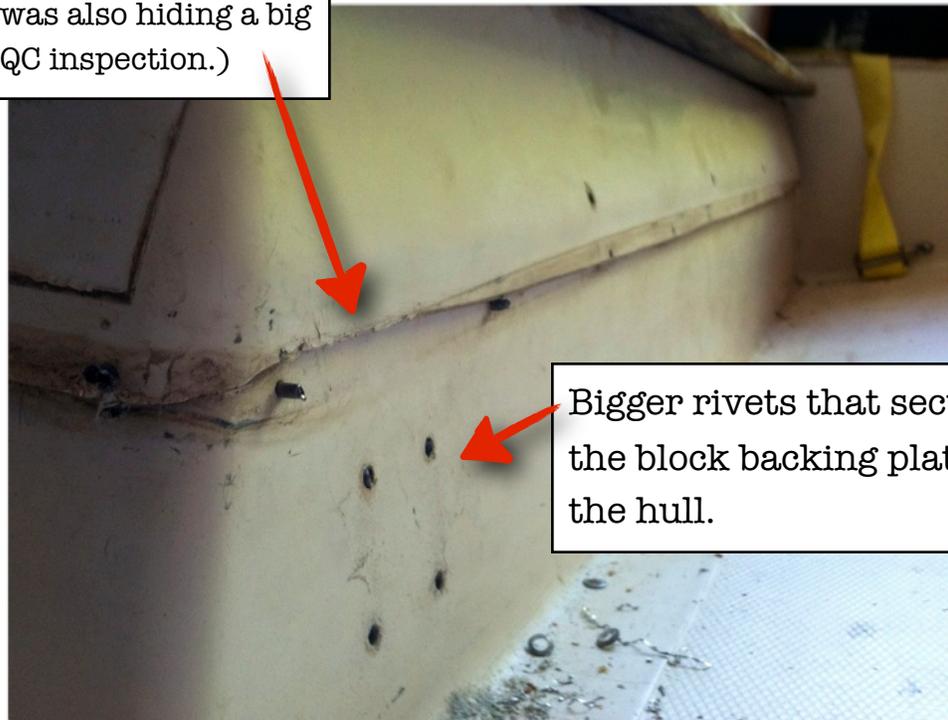
Rivet removal in progress.  
(It seems the trim was also hiding a big "whoops" from the QC inspection.)

**Step 2:** Carefully drill out the tops of the  $\frac{1}{8}$ " rivets that hold the aluminum trim hiding the cap overlap with the bottom.

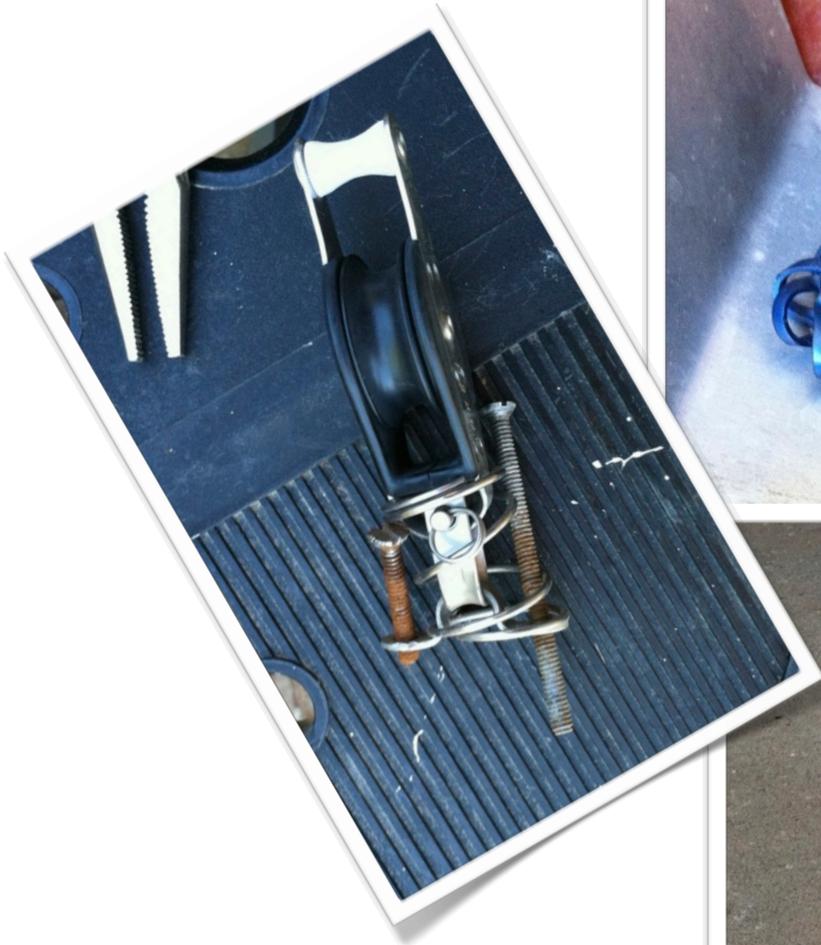
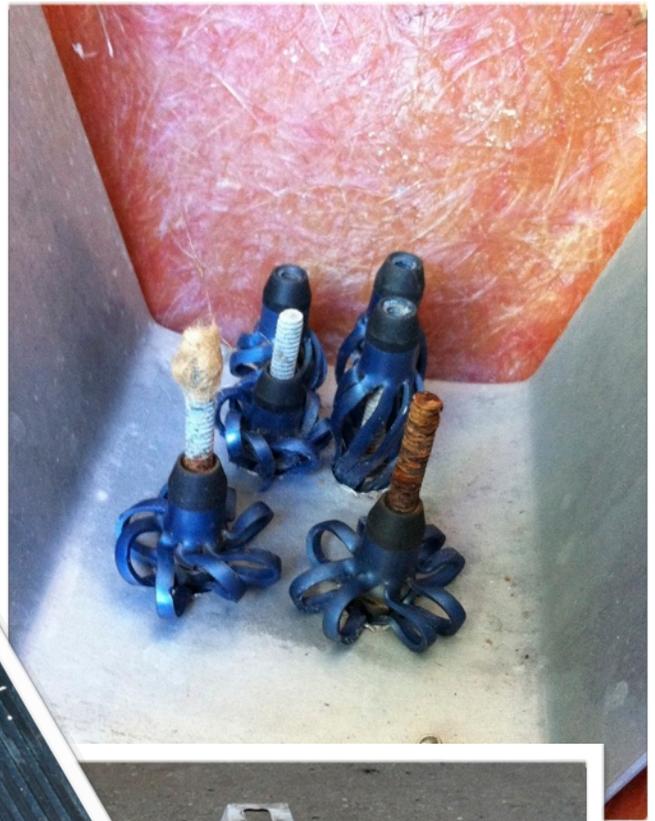
Obviously not stainless. Instead of nuts and washers, what you see here are plastic doo-dads and rusted bolts.

Furthermore, those plastic doo-dads acted as  $\frac{1}{4}$ " deep spacers in the fiberglass and metal backing plate.

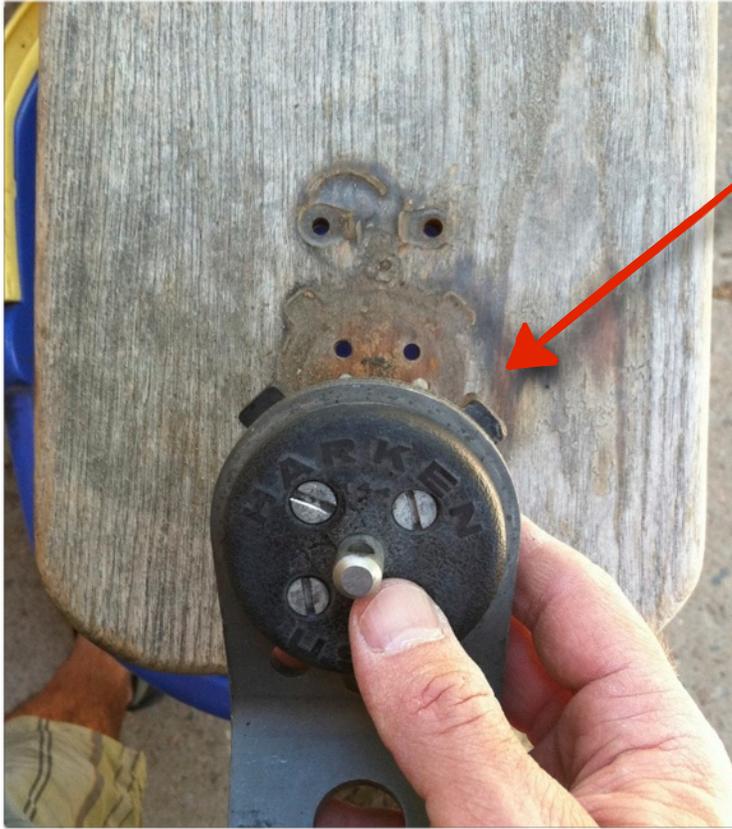
**Note** the orientation of the swivel base...

The stoppers (black tabs at 11:00 and 1:00) keep the swivel cleat from interfering with the mainsheet block.
