# 1979 Mutineer

## Centerboard Trunk Removal

June 30, 2011

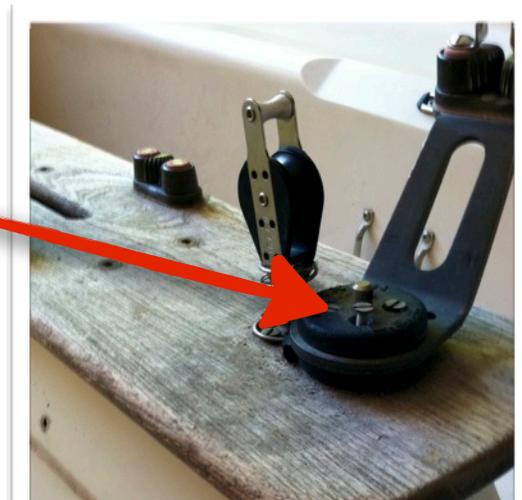
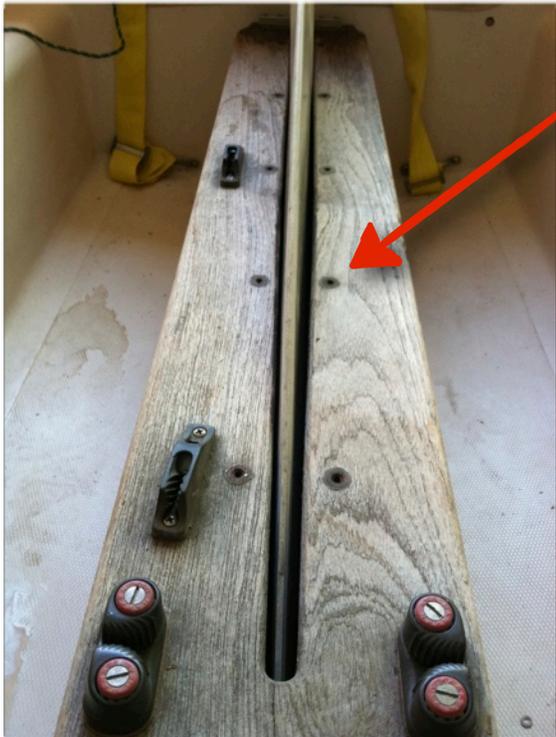
Yep. The mainsheet block and swivel base are bolted through not only the teak cap but also through a hidden metal backing plate that is secured to the fiberglass base of the centerboard trunk.

**Step 1:** Remove the 6 sets of Stainless wood screws that secure the cap to the centerboard trunk.

**Step 2:** Carefully drill out the tops of the  $\frac{1}{8}$ " rivets that hold the aluminum trim hiding the cap overlap with the bottom.

**Step 3:** Replace the bit with something larger to drill out the tops of the  $\frac{3}{16}$ " rivets that perform the real task of securing the cap to the hull. They live above the trim strip in a few places and below at the aft end where they secure the block backing plate to the hull.
